TECH NOTE

Power Smart Keypad Moisture Ingress

Power Smart Keypad (P/N SHP-TP-PS)

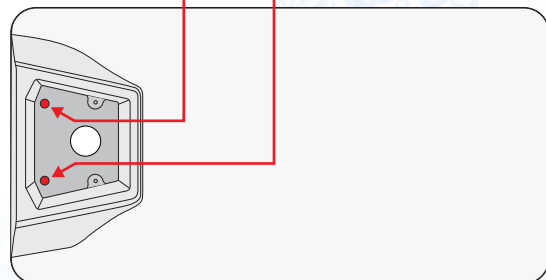
Step 4

Moisture ingress into touchpad through back of casing due to drain holes on Heat Pump Lid either clogged or not drilled

Ensure drain holes are not blocked and have been drilled out. Drill holes if not already done so in the lid.
